2019 Wetland Health Evaluation Program Report

Dakota County, MN

February 2020

FORTIN
CONSULTING, INC.
serving the environment

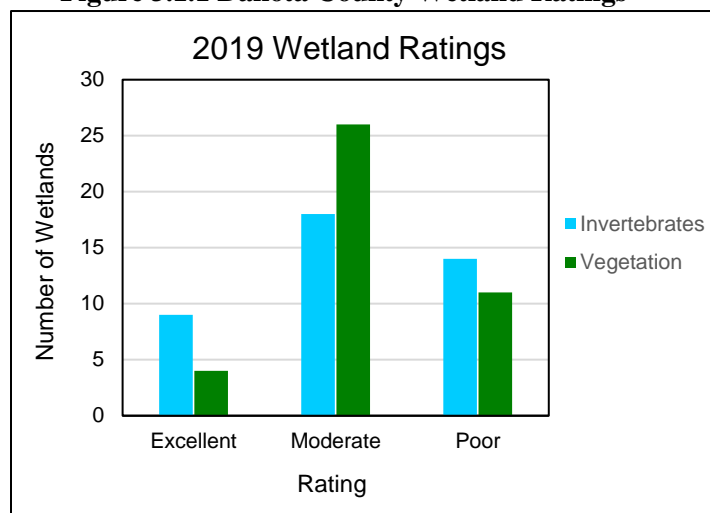
Figure 3.1.1 Dakota County Wetland Ratings

Figure 3.1.1 and Table 3.1.1 show the invertebrate and vegetation ratings for all of the wetlands assessed during the 2019 sampling season. Based on invertebrate scores, nine of the wetlands rated excellent, 18 of the wetlands were rated moderate, and 14 rated poor. Invertebrate scores ranged from 10 to 28 out of a maximum of 30 points.

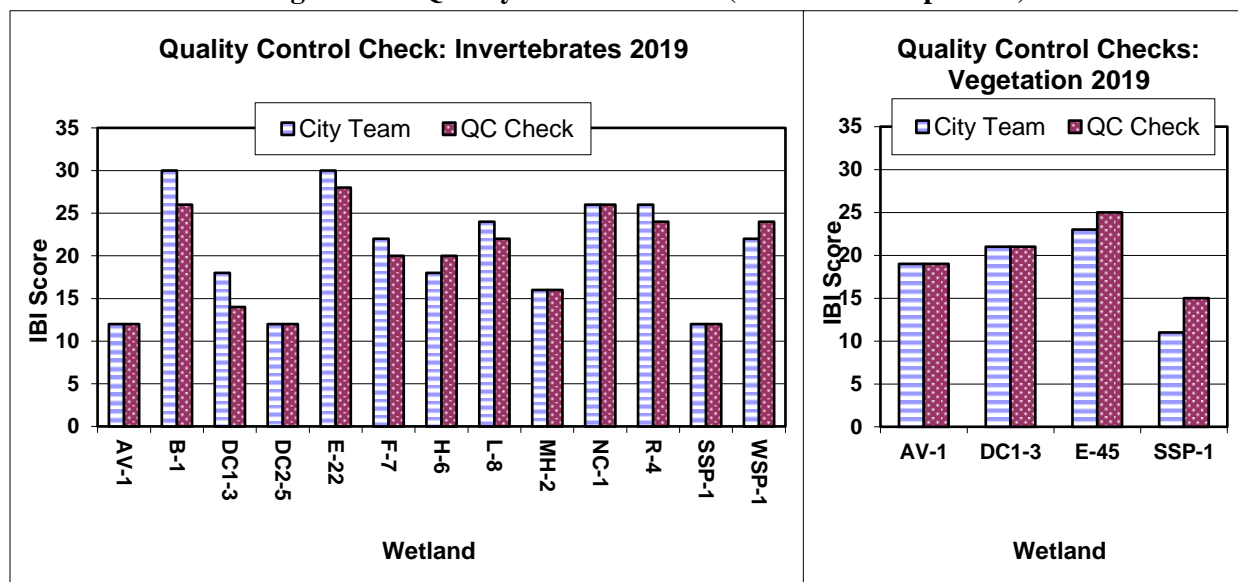
Figure 3.2.2 Quality Control Checks (IBI Score Comparison)

All team invertebrate and vegetation scores were found to be consistent with the quality control checks. Each WHEP team did very well in both their invertebrate identification and vegetation surveys. This shows that with a high quality program that provides good training and oversight, citizen volunteers can collect good usable data.

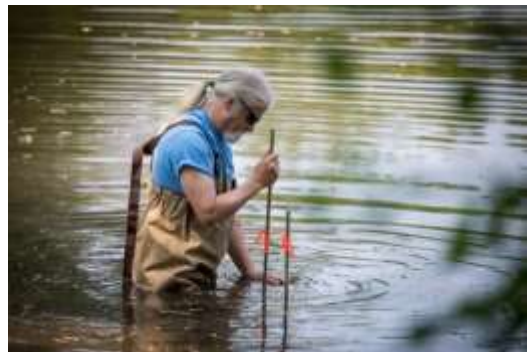
BRAD BLACKETT SETTING BOTTLE TRAPS

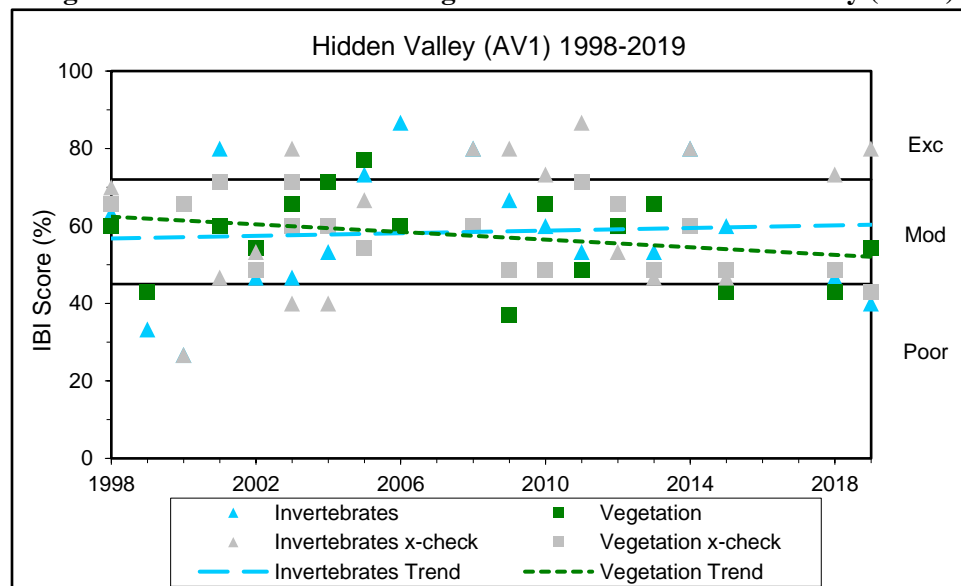
Figure 4.1.1 Invertebrate and vegetation trends for Hidden Valley (AV-1)

Site Summary: Hidden Valley has been surveyed 19 times since 1998. The invertebrate and vegetation health scores were inconsistent in 2019. The invertebrate data calculated poor wetland health while the vegetation showed moderate wetland health. Both the invertebrate and vegetation scores have been variable over the years fluctuating between moderate and poor. The extreme fluctuations may be due to factors such as changes in water level and plot placement. There was less of an invertebrate diversity in 2019 than 2018; though the team noted that the bottle traps contained tadpoles when collected. Overall, the invertebrates trend appears to be stable, if not improving slightly, while the vegetation trend appears to be declining. Hidden Valley was cross-checked by another WHEP team in 2019. The scoring between the City team and cross-check team was inconsistent for both invertebrate and vegetation health. The invertebrate scores differed by 40 percent. The City team scored poor while the cross-check team scored excellent for invertebrate health. The cross-check team observed a greater invertebrate diversity than

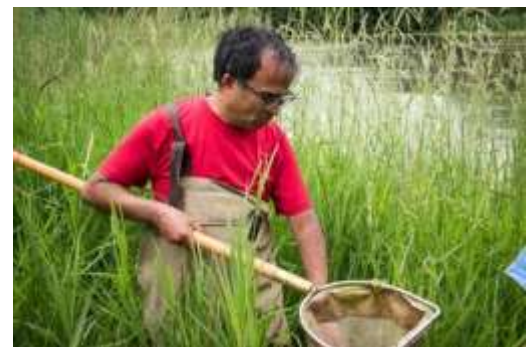
GUTPHAN NAMBOODIRIPAD
SAMPLING FOR INVERTEBRATES

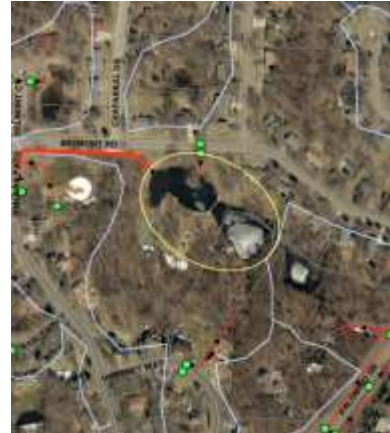
Belmont Park (AV-6), also known as BD-P10, is a 1.3-acre, type 3 wetland within the BD-10 subwatershed within the Black dog Watershed Management Organization. The wetland watershed includes approximately 202 acres, of which 32 acres drains directly. The watershed has 20 percent impervious surface. There is one inlet at the eastern border, one outlet along the northern border, and one outlet along the southern border. The northern inlet now passes through a filter berm and pretreatment cell. There is a lift station at the northwest corner of the wetland. This wetland is part of the City's stormwater management plan, and is designated as a Manage 1 Restore wetland with a goal to continue monitoring periodically over time.

The surrounding area is residential, and the wetland is immediately surrounded by parkland including natural space and nearby tennis courts. Belmont Road, on the north side of the wetland, was reconstructed in 2017. A small treatment cell was added to pretreat a portion of the road runoff from Belmont Road, Chaparral Drive, and Shoshoni Trail at that time. The pretreatment cell settles out some large sediments before they reach the pond. Some sediment was removed from the pond at that time (delta from northern inlet). The City placed barley straw pellets within the pond in an effort to control algae for several years, but discontinued that practice starting in 2017.

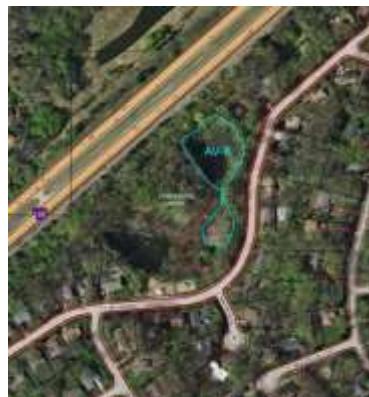
Chaparral Pond (AV-8), also known as BD-P14, is a 1.5-acre, type 4 wetland within the BD-14 subwatershed within the Black dog Watershed Management Organization. The wetland watershed includes approximately 110 acres, of which 44 acres drains directly. The watershed has 30 percent impervious surface. There is one inlet along the southern border, one inlet along the east side (northern lobe), one equalizer pipe along the west border (southern lobe), and one outlet on the northern end of the wetland that drains towards Burnsville. This wetland is part of the City's stormwater management plan, and is designated as a Manage 1 Restore wetland with a goal to continue monitoring periodically over time.

The area surrounding the wetland is residential. A decent sized buffer surrounds portions of the wetland. Historic aerial photos show increased open water over time. It is possible that a portion of the wetland was excavated in the past, prior to WCA, for stormwater management purposes. There has been nearby road reconstruction in 2016 and 2017. Some sumps to catch sediment were added pond inlets from the street at the time of reconstruction.

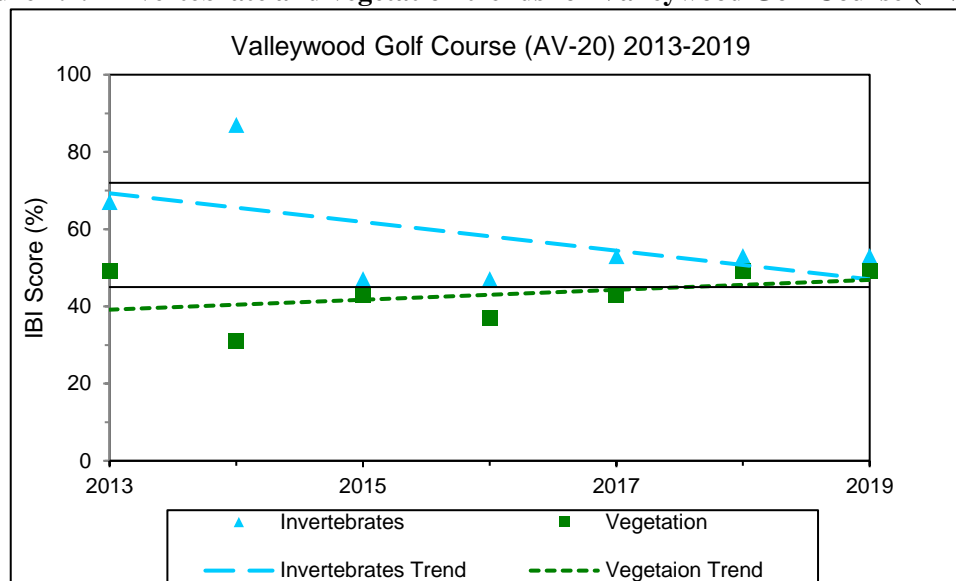
Figure 4.1.4 Invertebrate and vegetation trends for Valleywood Golf Course (AV-20)

Site summary: This is the seventh consecutive year that AV-20 has been monitored through WHEP. The wetland health scores were the same in 2018 and 2019. The invertebrate and vegetation health scores were consistent in 2019, both scoring moderate. Invertebrate and vegetation health scores have been stable the past four years. Overall, the invertebrate trend is declining since first monitored in 2013 while the vegetation trend remains stable.

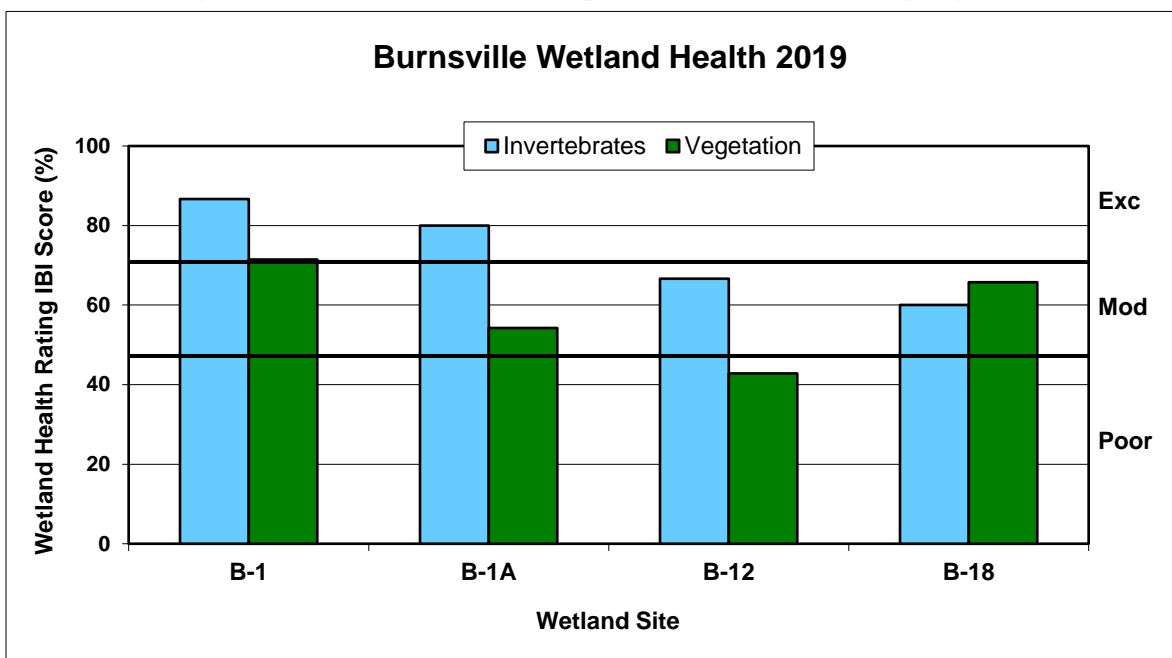
Figure 4.2 Burnsville site scores (percent) for the 2019 sampling season

Figure 4.2 presents an overall view of wetland health for all of the 2019 monitoring sites in Burnsville based on the IBI scores for invertebrates and vegetation presented as a percent. Figure 4.2 also illustrates the consistency between the IBI scores (in percent form) for each wetland sampled. Invertebrate and vegetation scores that differ by ten percent or less are considered consistent. Based on the IBI scores, a wetland health rating is assigned as excellent, moderate or poor. The Burnsville wetlands exhibited poor to excellent wetland health based on invertebrate and vegetation data. Only wetland B-12 rated poor for vegetation. B-1 and B-1A scored excellent for invertebrates. Invertebrate and vegetation scores were greatly inconsistent for B-1, B-1A, and B-12, differing by 16, 26, and 24 percent, respectively.

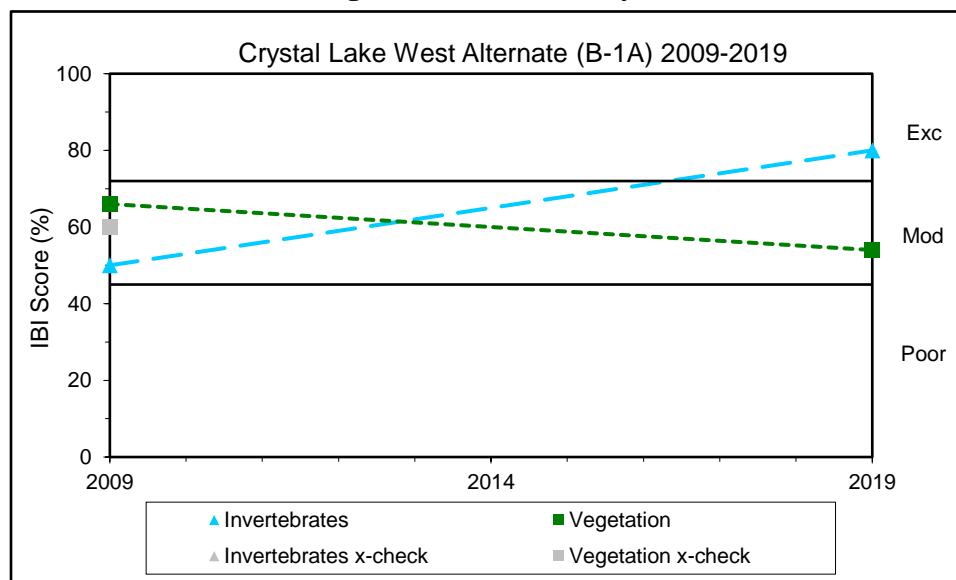
Figure 4.2.2 Invertebrate and vegetation trends for Crystal Lake West Alternate (B-1A)

Site summary: This is the second time that B-1A has been surveyed since 2009. Invertebrate and vegetation scores were inconsistent, differing by 26 percent. More data would help assess a more reliable health trend.

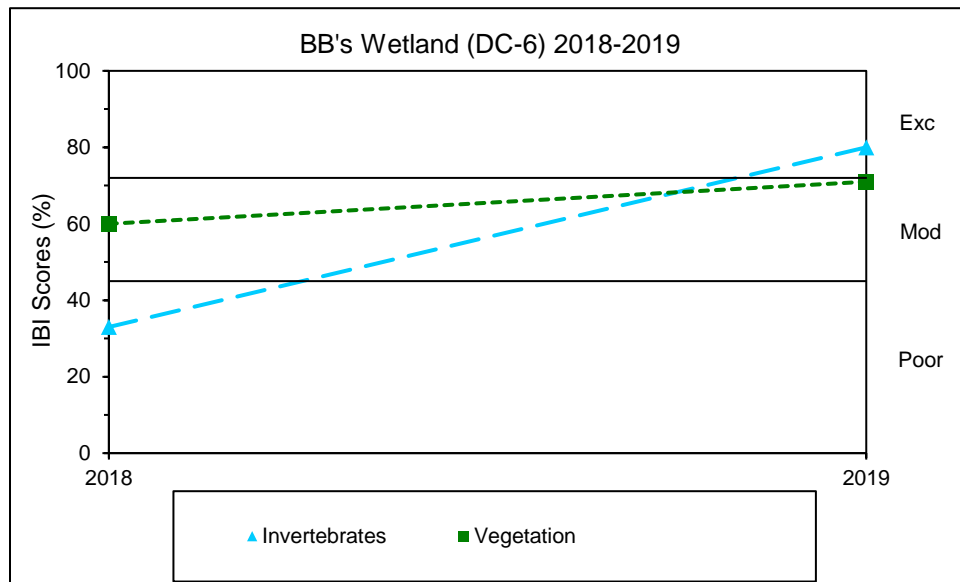
Figure 4.3.5 Invertebrate and vegetation trends for BB's Wetland (DC-6)

Site summary: This is the second year that BB's Wetland has been monitored by WHEP. The invertebrate and vegetation scores were consistent with each other. The invertebrate score indicates excellent wetland health. A larger diversity of vegetation and invertebrates were found in 2019. More years of monitoring are needed to determine reliable wetland health trends.

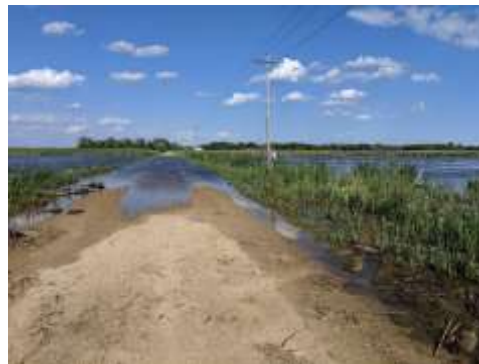
FLOODING OF 180TH STREET MARSH 2019
